# Debris/Ice/TPS Assessment And Photographic Analysis For Shuttle Mission STS-44

Gregory N. Katnik  
NASA/Kennedy Space Center

November 24, 1991

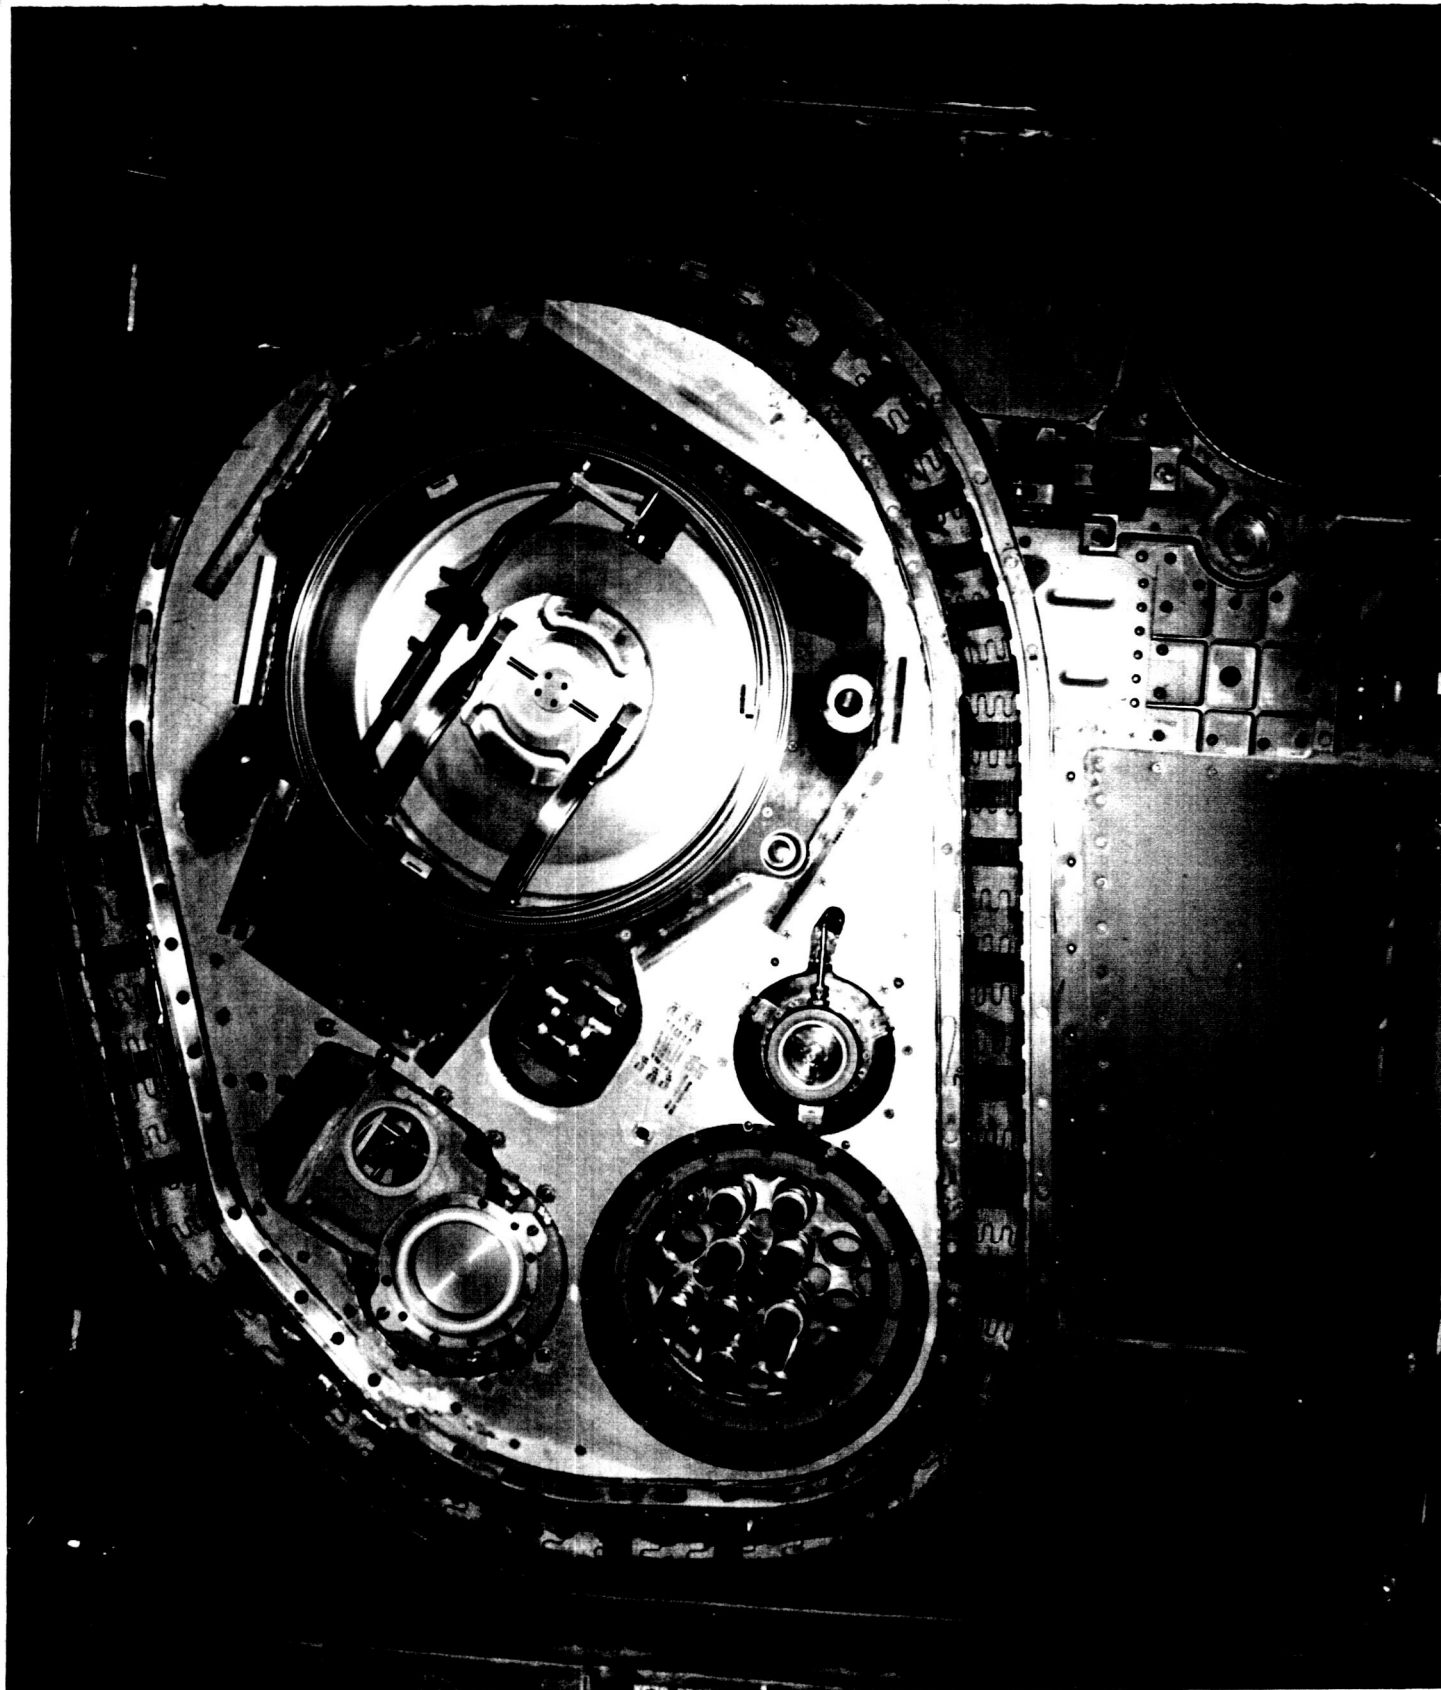
Overall view of the LO2 ET/ORB umbilical. The separation ordnance device debris plunger in EO-3 was seated and appeared to have functioned properly. There was no significant heat intrusion past the ET door thermal barrier.
